Muirfield Village Condos
1265 S. Aaron
Mesa, AZ

Summary Report of Damages Caused by UCI

Date: 8-15-22

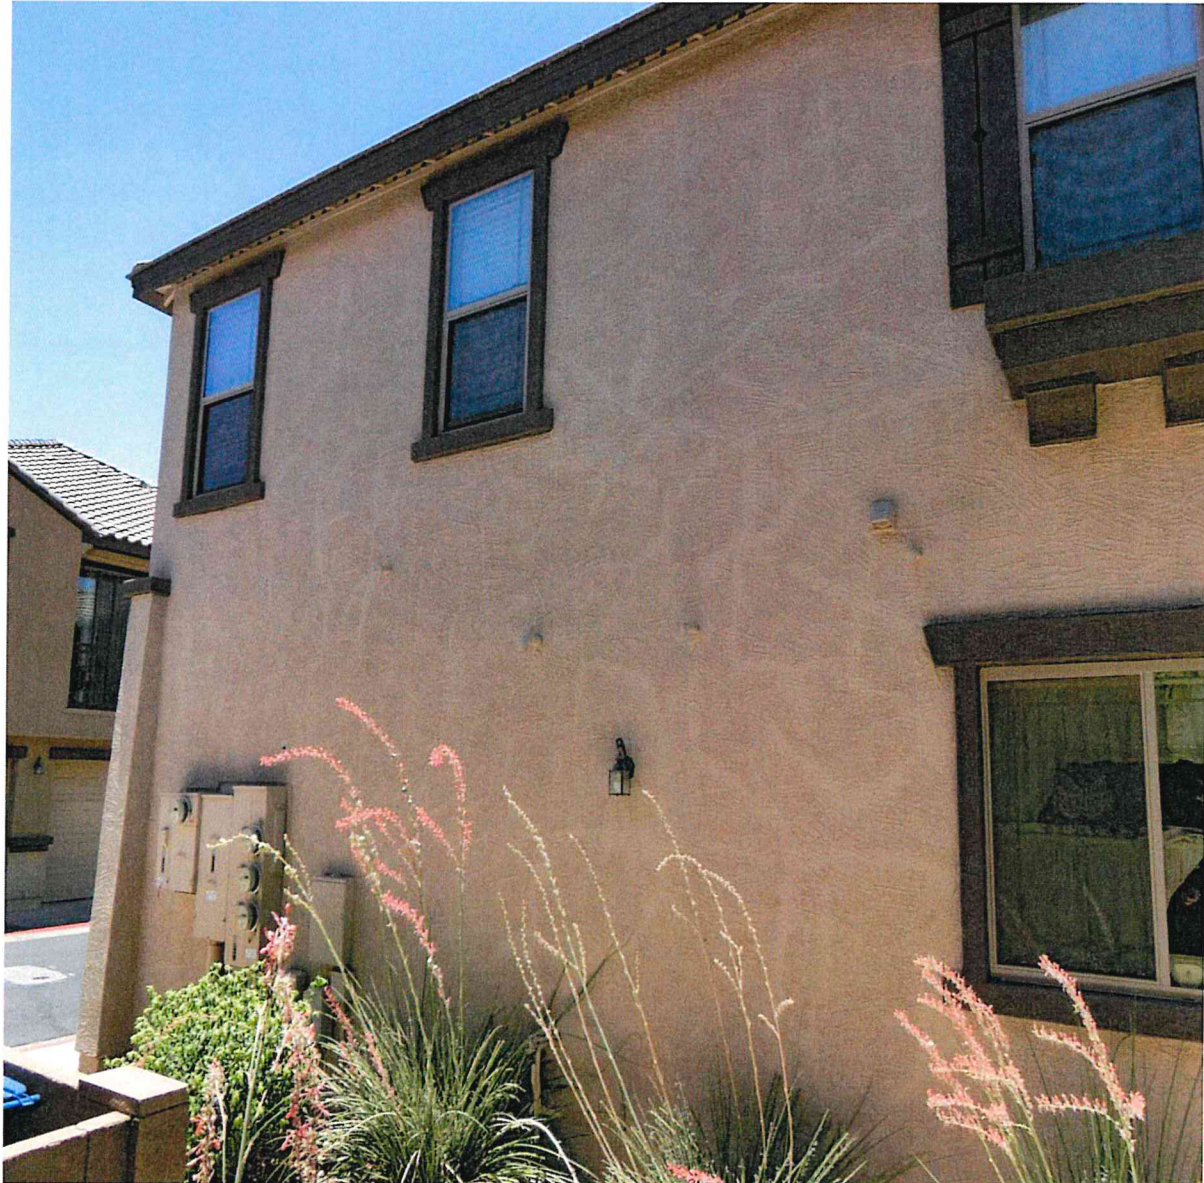
PHOTO #6

Prior to Unforgettable Coatings performing its stucco crack repair work at the community there: (1) were thousands of feet of stucco cracks collectively on all 488 wall planes (122 buildings x 4 walls per building). See PHOTOS 6-11. The HOA contracted with UCI to fill those cracks before painting so that the cracks would be less noticeable. UCI, however, did not properly fill the cracks.

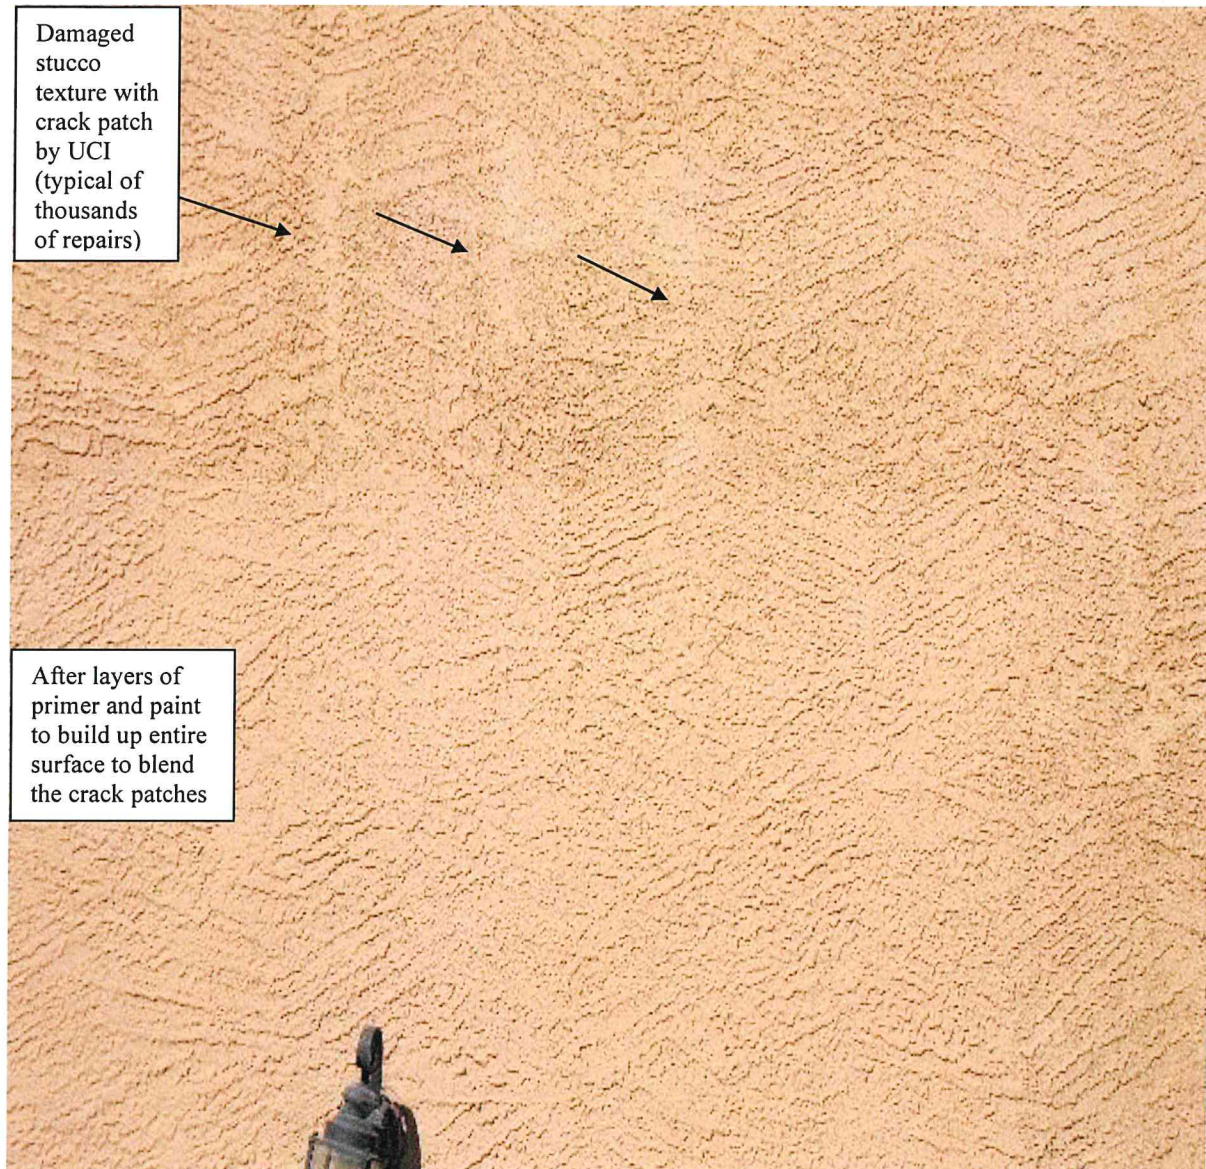
PHOTO #14

To repair the above, the HOA had three (3) choices: (1) re-apply stucco and finish on every wall plane; (2) remove the caulking that UCI applied over every crack, if possible (which it was not without causing more damage); or (3) to apply enough paint to the stucco that UCI did not apply the caulking onto (i.e., the stucco in between all of the cracks) to build the surface of that stucco finish up to match or blend with the caulking build up that UCI's stucco crack repair methodology created on each side of every crack that it attempted to repair. See PHOTO 14.

The HOA elected number 3 above – which was again, to apply enough paint to the stucco that UCI did not repair so that it would be built up enough to blend in with the stucco that UCI damaged by applying a buildup of caulking on each side of every crack that it repaired. This repair was not to UCI's own work. Rather it was to what was beforehand, the undamaged stucco system – i.e., the stucco that UCI did not repair, had to now be altered to make it blend in with the stucco that UCI damaged when performing its improper crack repairs,
